## **APPENDIX G**

### **DPR Forms**

State of California — The Resources Agency  
DEPARTMENT OF PARKS AND RECREATION  
**PRIMARY RECORD**

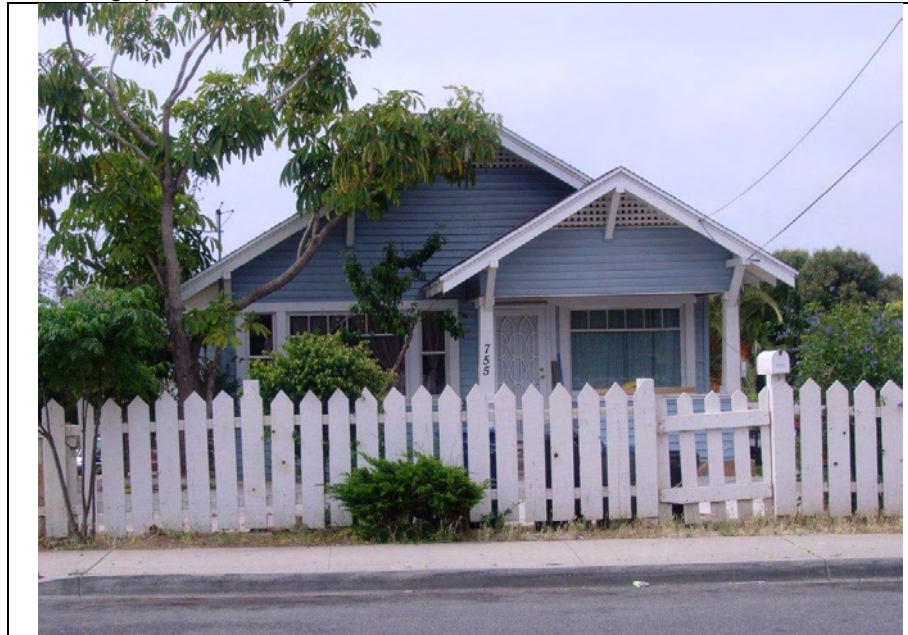
755 Ada Street was constructed in 1912 in the Craftsman style. It is a one-story single family residential building located on the south side of Ada Street between Industrial Boulevard and Frontage Road. The residence has a wood frame, rectangular floor plan with a concrete foundation. The exterior is clad in horizontal wood board siding. The roof is a moderately-pitched front gable roof with overhanging eaves and exposed rafter tails and clad in composition shingles. On the north elevation, a concrete walkway leads to a partial-width porch with a front gable roof. The porch has tapered wood columns sitting atop a low wall clad in the same exterior siding. The primary entrance is located within the porch and consists of a single wood door obscured by a metal security door. The windows consist of double hung wood sash, and fixed picture windows. There are vents underneath the gable ends. There is one chimney located within the roofline. Additions include a one-story shed roof extension on the east elevation. Modifications to the building include the replacement of some windows. Landscape features include a fenced-in yard and a concrete front driveway.

View looking south at the building.

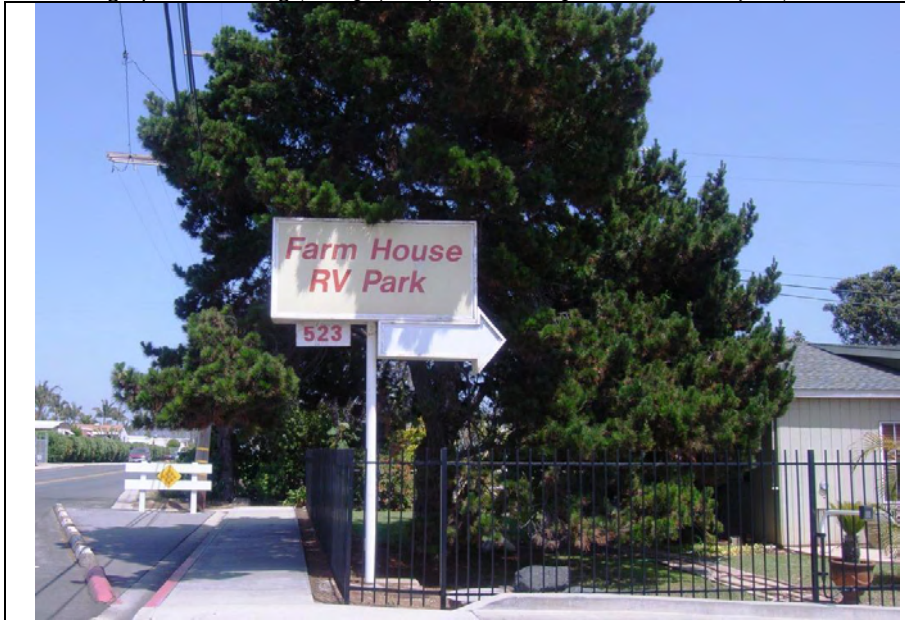
View looking east at the entrance sign.

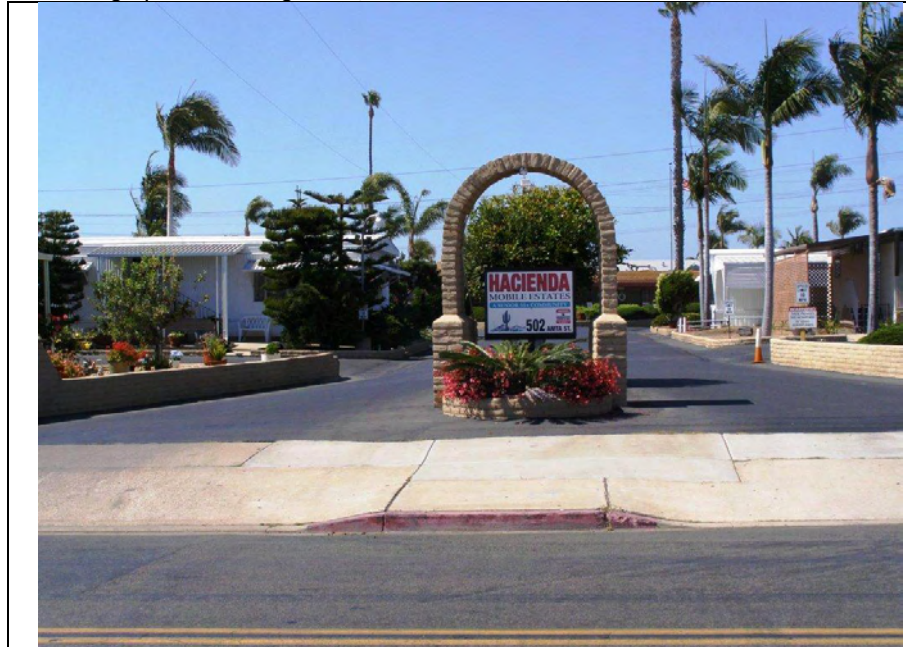
\*P3a. Description: (Describe resource and its major elements. Include design, materials, condition, alterations, size, setting, and boundaries)

View looking north at the entrance.

502 ANITA ST is not recommended eligible as a Chula Vista Historic Resource under any NRHP or CRHR or local criteria. While 502 ANITA ST was constructed as a result of the Post War development boom, it is not the best example of this property type and therefore not eligible for Criteria A or 1. Additionally, no significant persons were identified in association with the property and it is not recommended eligible under Criteria B or 2. Because 502 ANITA ST does not possess particular architectural styles or method of construction it is not a good representative of the style and is not recommended eligible under Criteria C or 3.

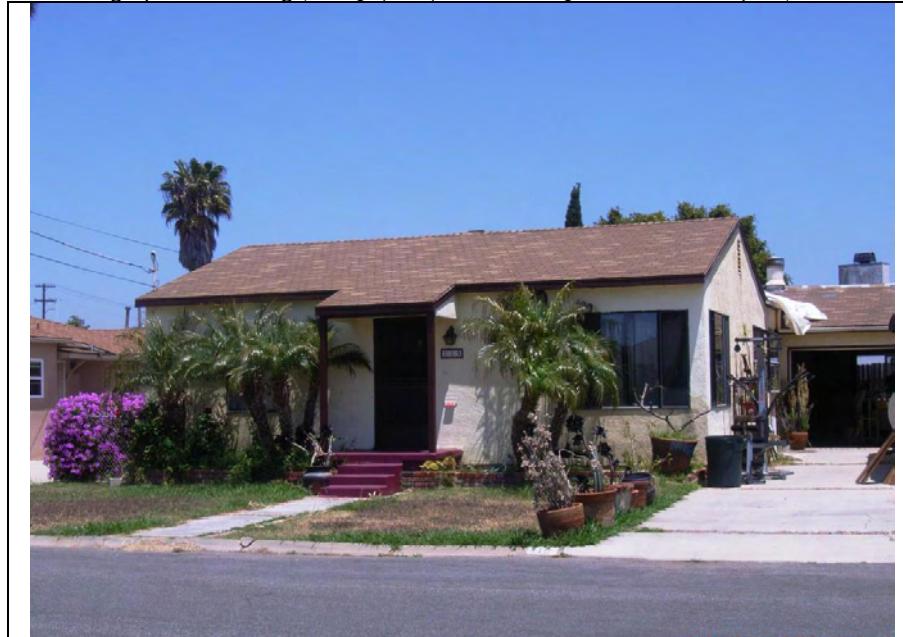
119 Brightwood Avenue was constructed in 1950 with features of the Minimal Traditional style. It is a one-story single family building located on the east side of Brightwood Avenue between Flower and D streets. The residence has a wood frame, rectangular floor plan with a concrete foundation. The exterior is clad in stucco siding. The roof is a moderately-pitched side gable roof with shallow eaves and clad in an asphalt roll. On the west elevation, a concrete walkway and steps lead to a partial-width porch with a shed roof. Squared wood posts support the porch roof. The primary entrance is located within the porch and consists of a single wood door. The windows consist of aluminum sliding windows. There is an attached garage located at the rear of the property. Modifications to the building include the replacement windows. Landscape features include a side driveway and a front yard.

View looking east at the building.

119 BRIGHTWOOD AV is not recommended eligible as a Chula Vista Historic Resource under any NRHP or CRHR or local criteria. In considering the building within the historic context prepared for this survey, it does not appear to be associated with any significant themes or patterns in history and therefore not eligible for Criteria A or 1. Additionally, no significant persons were identified in association with the property and it is not recommended eligible under Criteria B or 2. Although 119 BRIGHTWOOD AV possesses some stylistic features of Minimal Traditional style, it is not a good representative of the style and is not recommended eligible under Criteria C or 3.

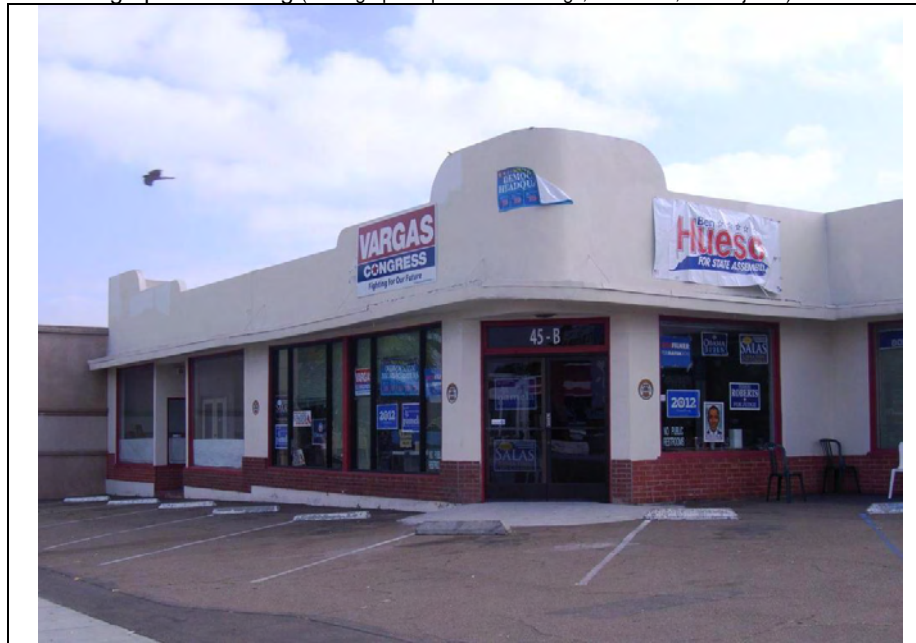
45 Broadway was constructed in 1952 in the Streamline Moderne style. It is a one-story commercial building located on the east side of Broadway, between McIntosh and C streets. The commercial building has a wood frame, L-shaped plan with a concrete foundation. The exterior is clad in stucco siding. The roof is flat with a raised and curved parapet. On the west elevation, an asphalt parking lot and concrete ramp leads to a storefront. Features include a streamline hood over the storefront doors and windows, as well as a brick veneer wall. There are two storefront entrances on the west façade. The primary entrance is located on the west elevation and consists of two glass plate doors surmounted by a transom. The windows consist of fixed glass plate windows. There is a parking lot in front of the building. Modifications to the building include the residing of the building, the replacement of doors and windows.

View looking northeast at the building.

45 BROADWAY is recommended eligible as a Chula Vista Historic Resource under NRHP, CRHR and local criteria. In considering the building within the historic context prepared for this survey, it does not appear to be associated with any significant themes or patterns in history and therefore not eligible for Criteria A or 1. Additionally, no significant persons were identified in association with the property and it is not recommended eligible under Criteria B or 2. 45 BROADWAY as an excellent local example of the Streamline Moderne style, and as such is recommended eligible as a Chula Vista Historic Resource under Criterion 3. Character defining features of the Streamline Moderne style include the curved corners on exterior walls, smooth stucco wall surface, emphasis on the horizontal orientation, flat roof with raised parapet. Following the same reasons, it is also eligible for the California Register of Historical Resources and National Register of Historic Places, on the local level, under Criterion 3 (CRHR) and Criterion C (NRHP). The building retains a significant degree of its building materials dating to the period of significance, especially in comparison to other similar properties. Overall it retains a high degree of integrity, especially of design, materials, and craftsmanship.

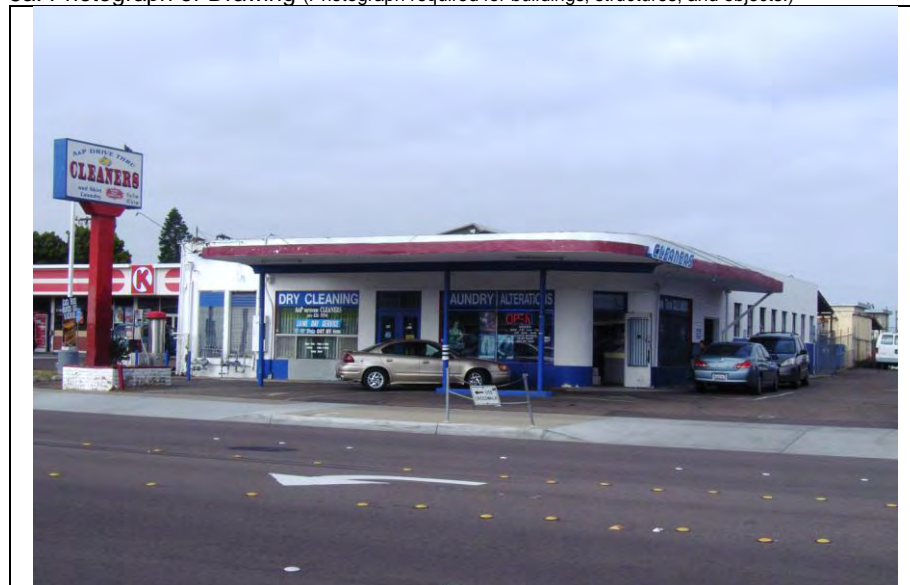
48 Broadway was constructed in 1945 in the Streamline Moderne style. It is a one-story commercial building located on the west side of Broadway, between McIntosh and C streets. The commercial building has a wood frame, rectangular floor plan with a concrete foundation. The exterior is clad in stucco siding. The roof is a flat. On the east elevation, an asphalt drive and concrete ramp leads to a corner storefront entrance. The primary entrances consist of a single wood door and double doors surmounted by transoms. The windows consist of fixed and aluminum slider, and hopper windows. There was a large carport that wraps around the north and east elevations.

View looking west at the building.

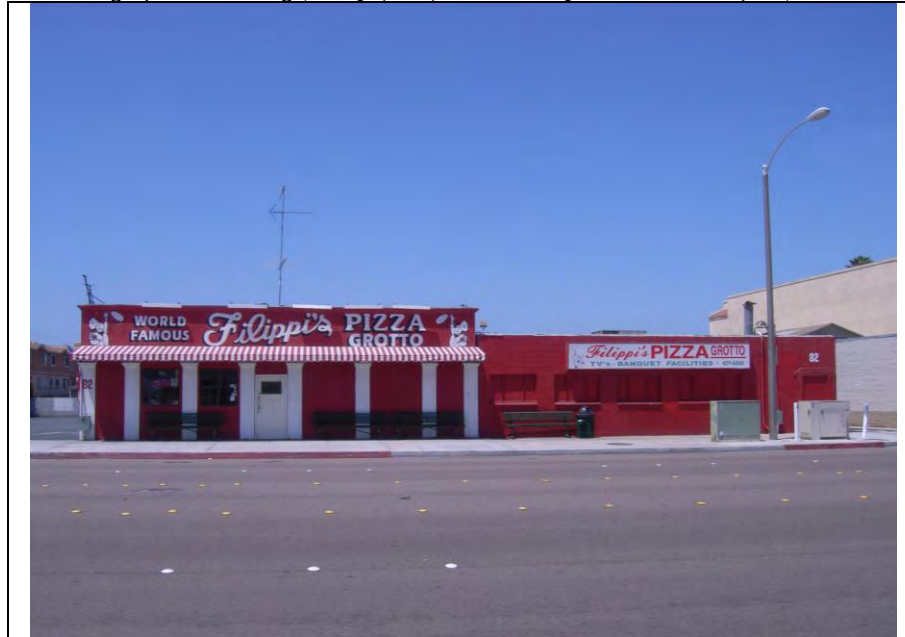
82 Broadway was constructed circa 1945 in the Post-War Commercial style. It is a one-story commercial building located on the west side of Broadway. The commercial building has a wood frame, rectangular floor plan with a concrete foundation. The exterior is clad in concrete block siding. The roof is flat. The primary entrance is located on the east elevation and consists of a single wood door. A vinyl awning covers the entrance on the east façade. The windows consist of fixed plate glass storefront windows. Other windows have been boarded-over with concrete blocks. Modifications to the building include the replacement of doors and the boarding-over of windows.

View looking west at the building.

82 BROADWAY is not recommended eligible as a Chula Vista Historic Resource under any NRHP or CRHR or local criteria. In considering the building within the historic context prepared for this survey, it does not appear to be associated with any significant themes or patterns in history and therefore not eligible for Criteria A or 1. Additionally, no significant persons were identified in association with the property and it is not recommended eligible under Criteria B or 2. Although 82 BROADWAY possesses some stylistic features of Post-war Commercial style, it is not a good representative of the style and is not recommended eligible under Criteria C or 3.

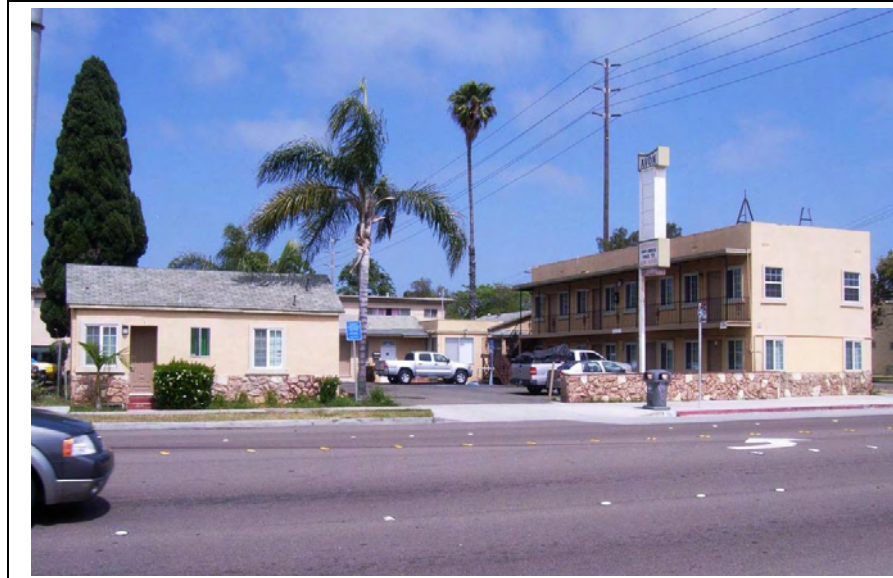
99 Broadway was constructed in 1952 in the Modern- non-residential style. It is a multi-story motel building located on the east side of Broadway. The motel has a wood frame, U-shaped floor plan with a concrete foundation. The exterior is clad in stucco and stone veneer water table siding. There are three sections to the motel; two are one-story and one is a two-story section. The roof on the one-story section has a side gable roof. The two-story section has a flat roof. The motel room entrances face the central parking lot. The windows consist of vinyl sash and sliding windows. There is a free-standing sign which reads, "Avon Motel." Additions include a one-story flat-roof section of the building. Modifications to the building include the replacement windows and doors. Landscape features include mature trees and grass.

View looking west at the building.

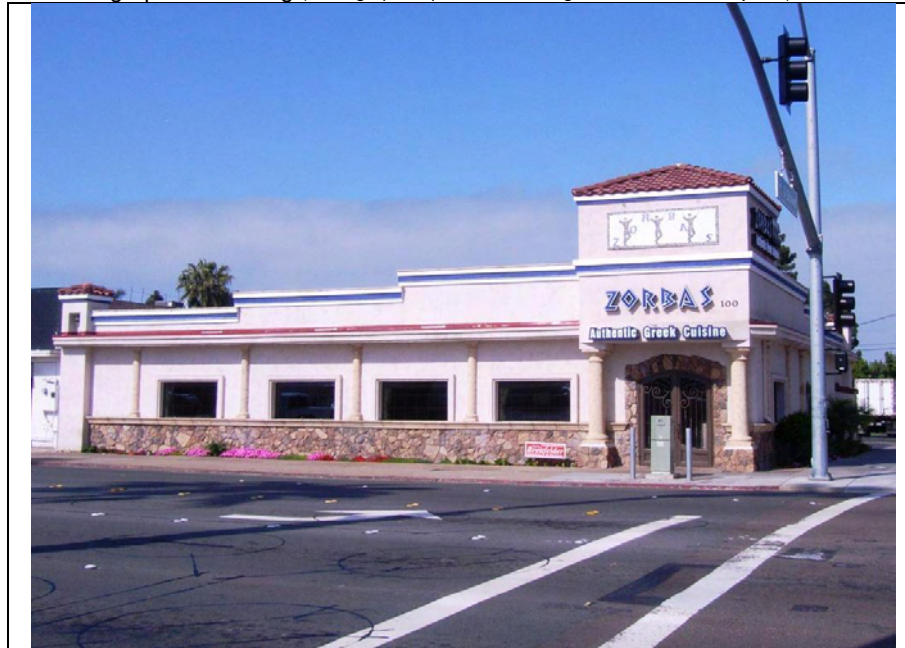
100 Broadway was constructed circa 1945 in the Post-War Commercial style. It is a one-story restaurant building located on the southeast side of Broadway and D Street. The commercial building has a wood frame, rectangular floor plan with a concrete foundation. The exterior is clad in stucco and lower stone veneer wall surrounding the building. The roof is flat with a raised stepped parapet and a corner cupola with a pyramidal red clay tile roof. The primary entrance is located on the west elevation and consists of two wood doors with glazing. The windows consist of fixed glass windows. Decorative features of the building include pilasters and decorative cornices. Modifications to the building include the replacement doors, windows and siding.

View looking west at the building.

100 BROADWAY is not recommended eligible as a Chula Vista Historic Resource under any NRHP or CRHR or local criteria. In considering the building within the historic context prepared for this survey, it does not a good representation of the significant themes or patterns in history and therefore not eligible for Criteria A or 1. The building could potentially be eligible for ist association with Bob Crowther, a prominent Chula Vista businessman and proprietor of the former Bob's Waffle Shop at this location. However, the building has lost too much of integrity (specifically of materials, design, workmanship, and feeling) and therefore no longer conveys its association under Criteria B or 2. Although 100 BROADWAY possesses some stylistic features of Post-War Commercial style, it has lost too much integrity since its original date of construction and is therefore not eligible under Criteria C or 3.

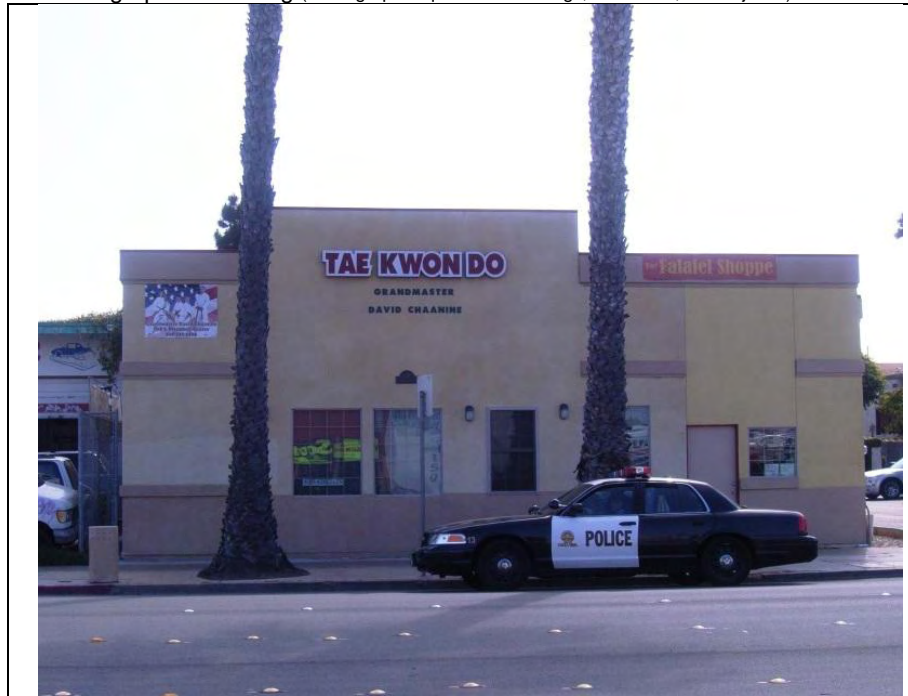
119 Broadway was constructed in 1925 in the Pre-War Commercial style. It is a two-story commercial building located on the east side of Broadway. The commercial building has a wood frame, rectangular floor plan with a concrete foundation. The exterior is clad in stucco siding. The roof is a moderately-pitched front gable roof with a false parapet storefront. On the east elevation, a concrete walkway leads to two storefronts. Two signs read, "Falafel Shoppe" and "Tae Kwon Do." The primary entrance is located on the west elevation and consists of a flush wood door. The windows consist of fixed multi-light windows. Modifications to the building include the stucco and replaced windows and doors.

View looking east at the building.

115 BROADWAY is not recommended eligible as a Chula Vista Historic Resource under any NRHP or CRHR or local criteria. In considering the building within the historic context prepared for this survey, it does not appear to be associated with any significant themes or patterns in history and therefore not eligible for Criteria A or 1. Additionally, no significant persons were identified in association with the property and it is not recommended eligible under Criteria B or 2. Although 115 BROADWAY possesses some stylistic features of Pre-War Commercial style, it has lost its integrity and is not a good representative of the style and is not recommended eligible under Criteria C or 3.

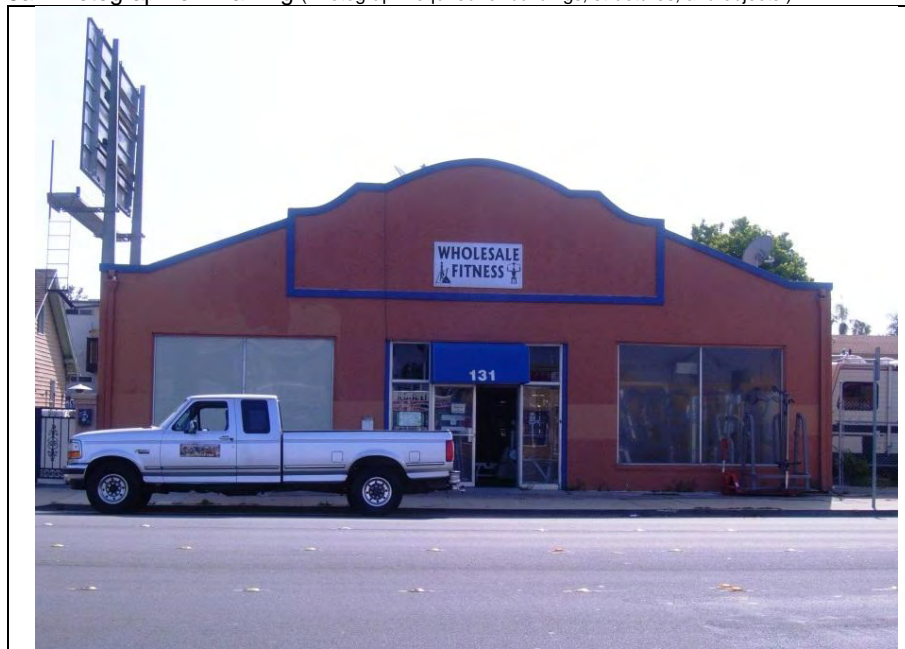
131 Broadway was constructed in 1945 in the Post-War Commercial style. It is a one-story commercial storefront building located on the east side of Broadway, between Flower and D streets. The commercial building has a wood frame, rectangular floor plan with a concrete foundation. The exterior is clad in stucco siding. The roof is flat with a raised parapet. On the east elevation, a concrete walkway leads to a glass storefront with two doors. The windows consist of aluminum fixed windows. Modifications to the building include the replacement siding, windows and doors.

View looking east at the building.

131 BROADWAY is recommended eligible as a Chula Vista Historic Resource under NRHP, CRHR and local criteria. In considering the building within the historic context prepared for this survey, it does not appear to be associated with any significant themes or patterns in history and therefore not eligible for Criteria A or 1. Additionally, no significant persons were identified in association with the property and it is not recommended eligible under Criteria B or 2. 131 BROADWAY as an excellent local example of the Post-War Commercial style, and as such is recommended eligible as a Chula Vista Historic Resource under Criterion 3. Character defining features of the Post-War Commercial style include the flat roof with a raised patterned parapet, large storefront windows with a main entry way, and a short setback from the sidewalk. Following the same reasons, it is also eligible for the California Register of Historical Resources and National Register of Historic Places, on the local level, under Criterion 3 (CRHR) and Criterion C (NRHP). The building retains a significant degree of its building materials dating to the period of significance, especially in comparison to other similar properties. Overall it retains a high degree of integrity, especially of design, materials, and craftsmanship.

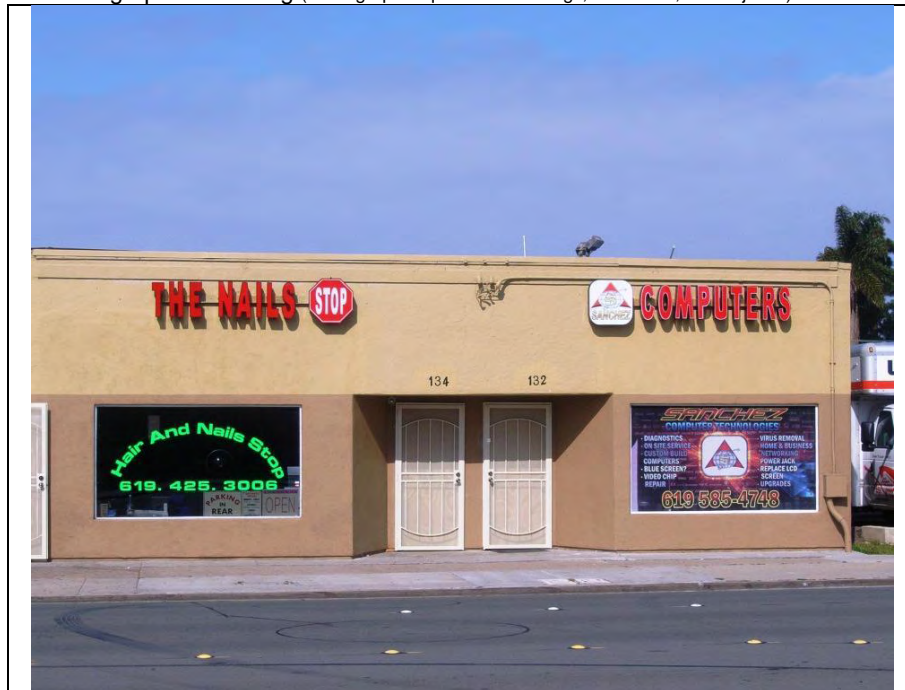
132-134 Broadway was constructed circa 1945 in the Post-War Commercial style. It is a one-story commercial building located on the west side of Broadway. The commercial building has a wood frame, rectangular floor plan with a concrete foundation. The exterior is clad in stucco siding. The roof is flat. On the east elevation, a concrete walkway leads to a recessed storefront entrance with two doors obscured by metal security doors. There are two fixed glass windows. Modifications to the building include the replacement siding and doors.

View looking west at building.

132-134 BROADWAY is not recommended eligible as a Chula Vista Historic Resource under any NRHP or CRHR or local criteria. In considering the building within the historic context prepared for this survey, it does not appear to be associated with any significant themes or patterns in history and therefore not eligible for Criteria A or 1. Additionally, no significant persons were identified in association with the property and it is not recommended eligible under Criteria B or 2. Although 132 BROADWAY possesses some stylistic features of Post-War Commercial style, it is not a good representative of the style and is not recommended eligible under Criteria C or 3.

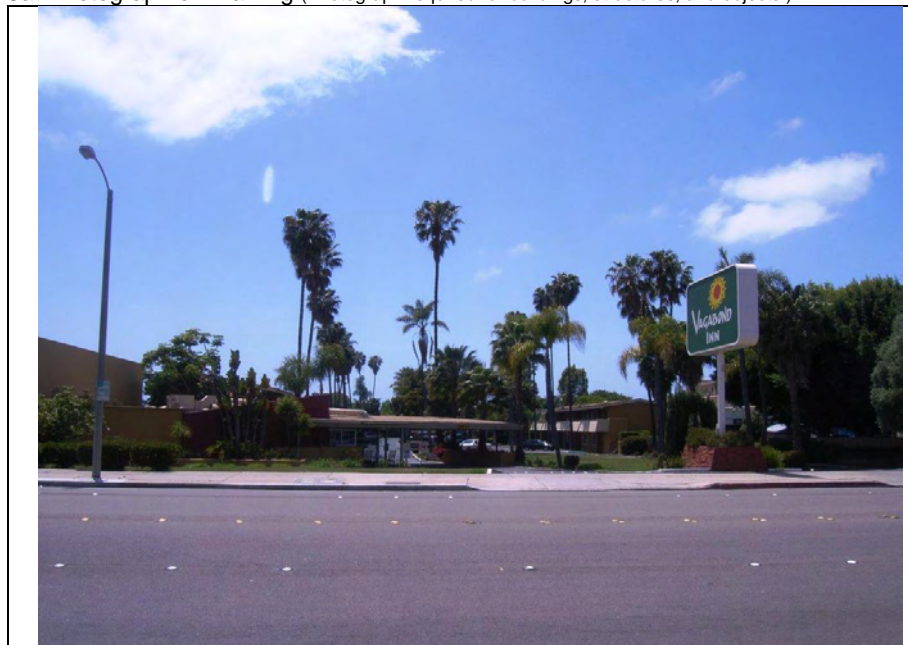
230 Broadway was constructed in 1969 in the Modern non-residential style. It is a one- and two-story motel building located on the west side of Broadway originally constructed as a Vagabond Inn and currently remains the same. The commercial building has a wood and steel frame, U-shaped plan with a concrete foundation. The exterior is clad in a brick and stone veneer. The roof of the main office building is widely-pitched with winged walls. The motel room buildings have two-stories and have side gable roofs. The one-story office building has a grouping of floor-to-ceiling storefront windows on the north façade and a carport entryway. The motel buildings have side staircases with pent roof siding in place of the second story railings. The windows consist of aluminum sliding windows. Landscape features include a central parking area with mature palm trees and surrounding grass yards.

View looking west at the building.

230 BROADWAY is recommended eligible as a Chula Vista Historic Resource under NRHP, CRHR and local criteria. 230 BROADWAY is eligible as a Chula Vista Historic Resource under Criterion 1 for its association with Chula Vista's tourism industry during the City Maturation period. Following the same reasons, it is also eligible for the California Register of Historical Resources and National Register of Historic Places, on the local level, under Criterion 1 (CRHR) and Criterion A (NRHP) under the area of significance of Tourism. No significant persons were identified in association with the property and it is not recommended eligible under Criteria B or 2. 230 BROADWAY as an excellent local example of the Modern style, and as such is recommended eligible as a Chula Vista Historic Resource under Criterion 3. Character defining features of the Modern style include the angular lines, varying siding materials, large storefront windows, shed roof and widely overhanging eaves. Following the same reasons, it is also eligible for the California Register of Historical Resources and National Register of Historic Places, on the local level, under Criterion 3 (CRHR) and Criterion C (NRHP). The building retains a significant degree of its building materials dating to the period of significance, especially in comparison to other similar properties. Overall it retains a high degree of integrity, especially of design, materials, and craftsmanship.

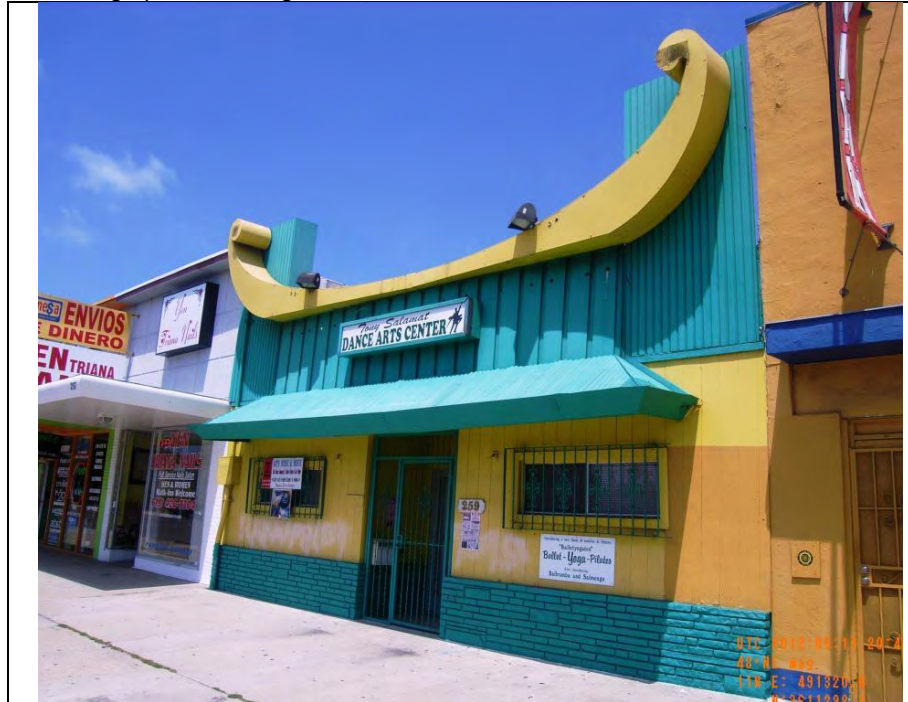
259 Broadway was constructed in 1952 in the Googie style. It is a one-story commercial building located on the east side of Broadway. The commercial building has a wood frame, rectangular floor plan with a concrete foundation. The exterior is clad in various siding which includes vertical wood boards and a lower brick wall veneer. The roof is flat with a raised parapet. The primary entrance is located on the west elevation and consists of a recessed storefront door that is accessed by a front metal security door. There is a metal hood that covers the front entryway on the west façade. The windows consist of aluminum sliding windows. Ornamental features of the building include a large metal swag that adorns the top part of the front façade. Modifications to the building include the replacement of siding and the addition of metal security bars over the entryway and windows.

View looking northeast at the building.

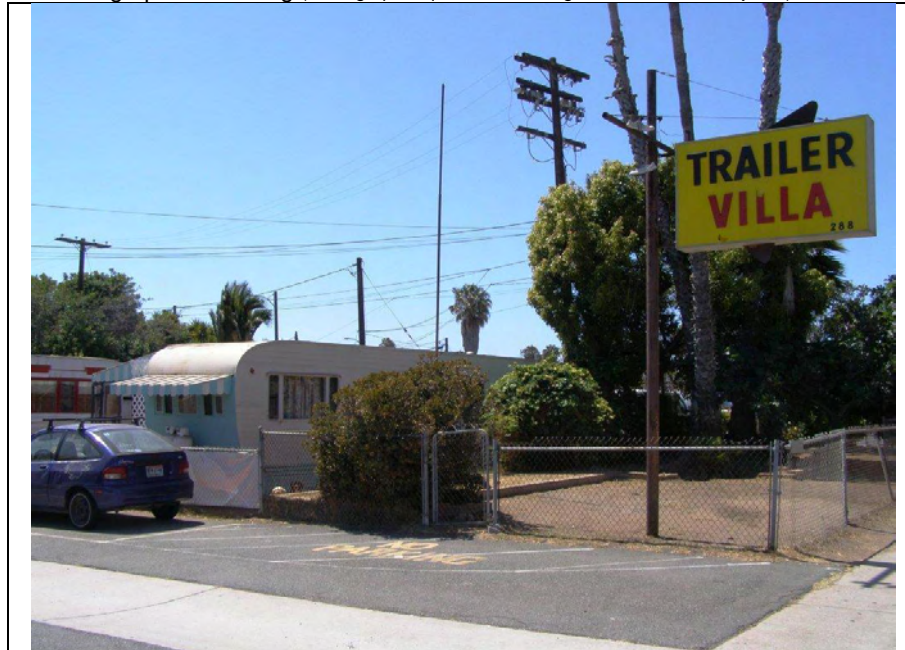
View looking northwest at the mobile  
estate. Photo taken May 11, 2012.

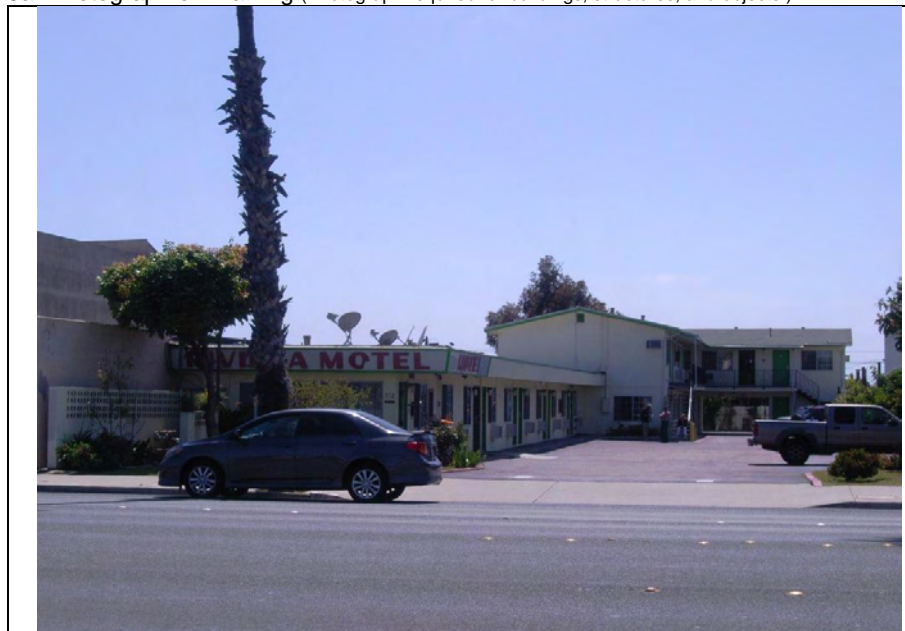
View looking west at the building.

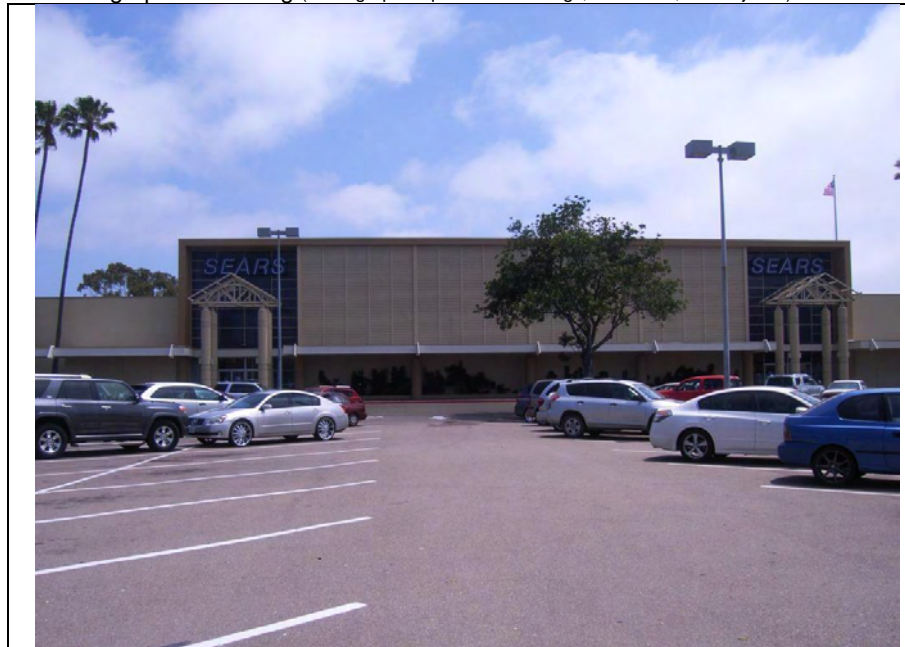
View looking south at the building.

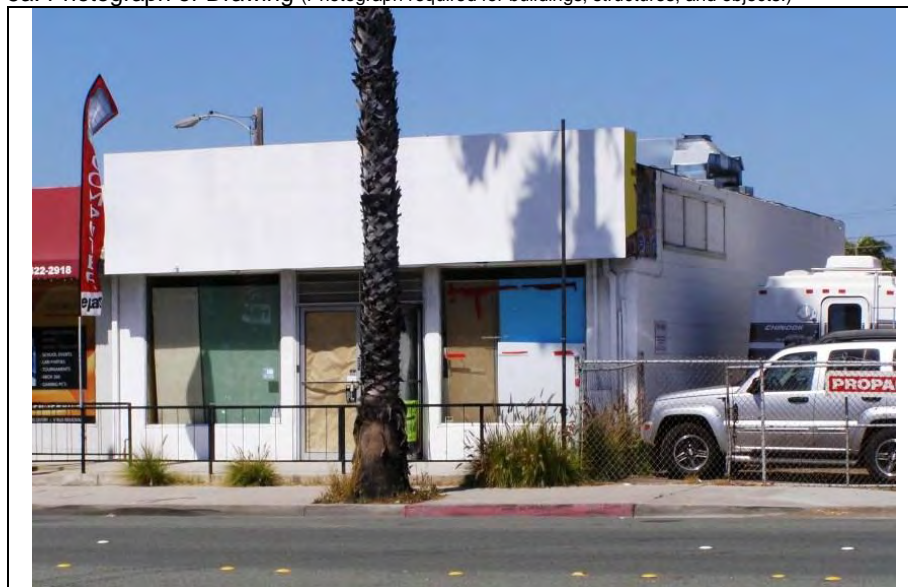
View looking east at the building.

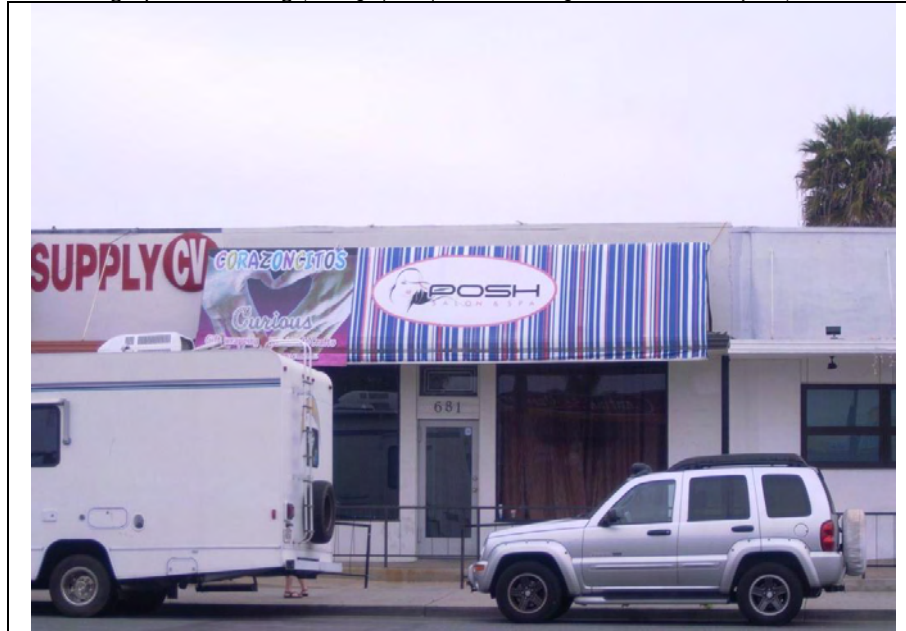
View looking east at the building.

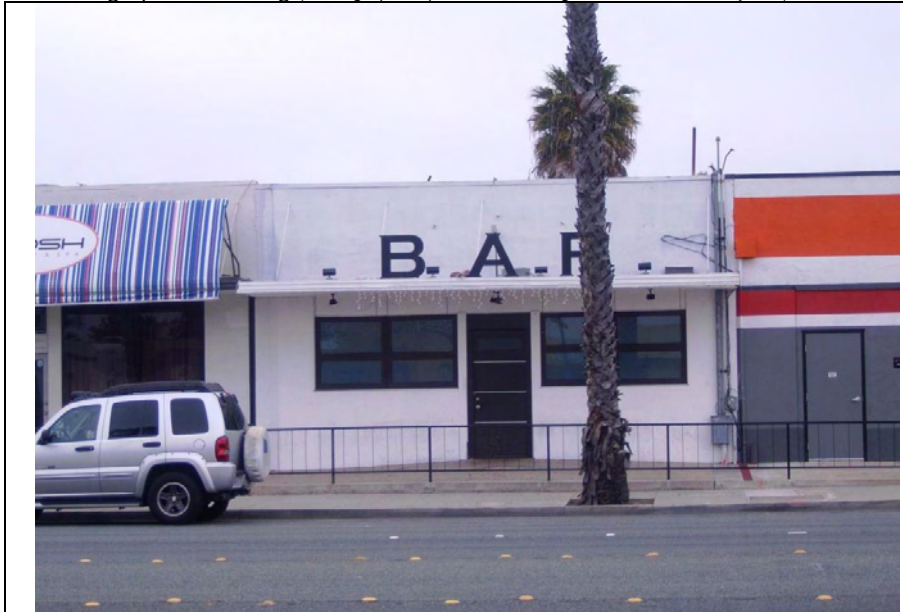
View looking east at the building.

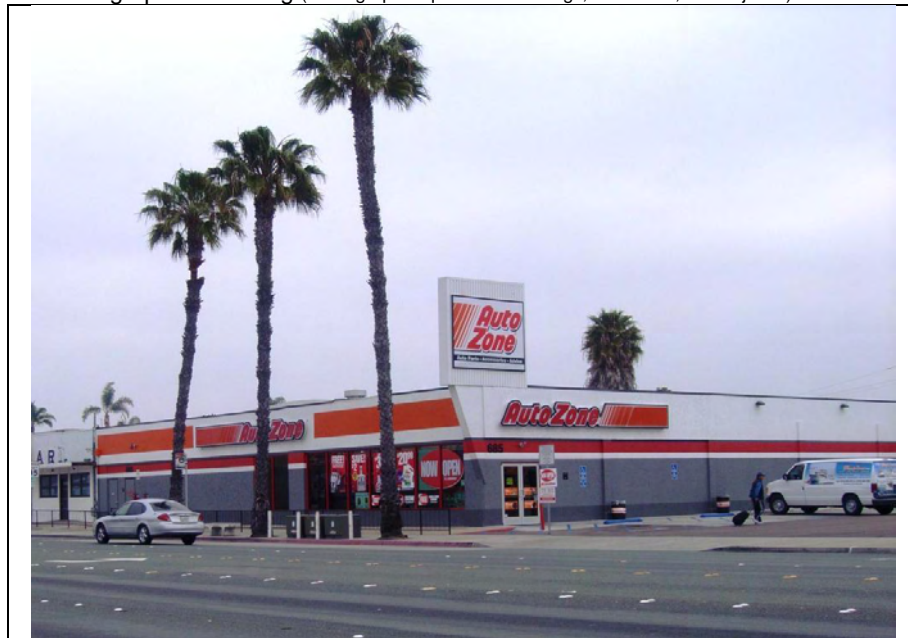
View looking northeast at the building.

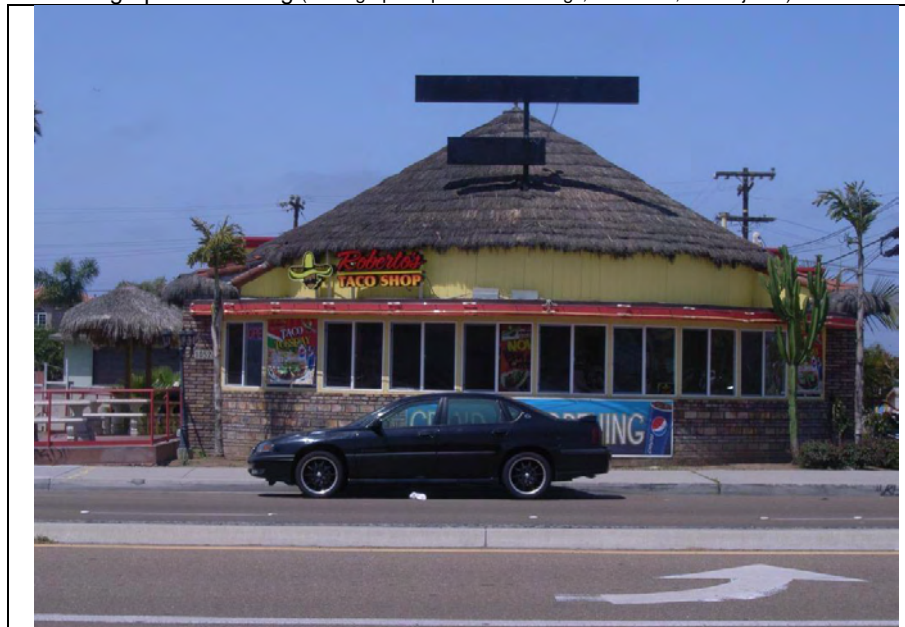
View looking west at the building.

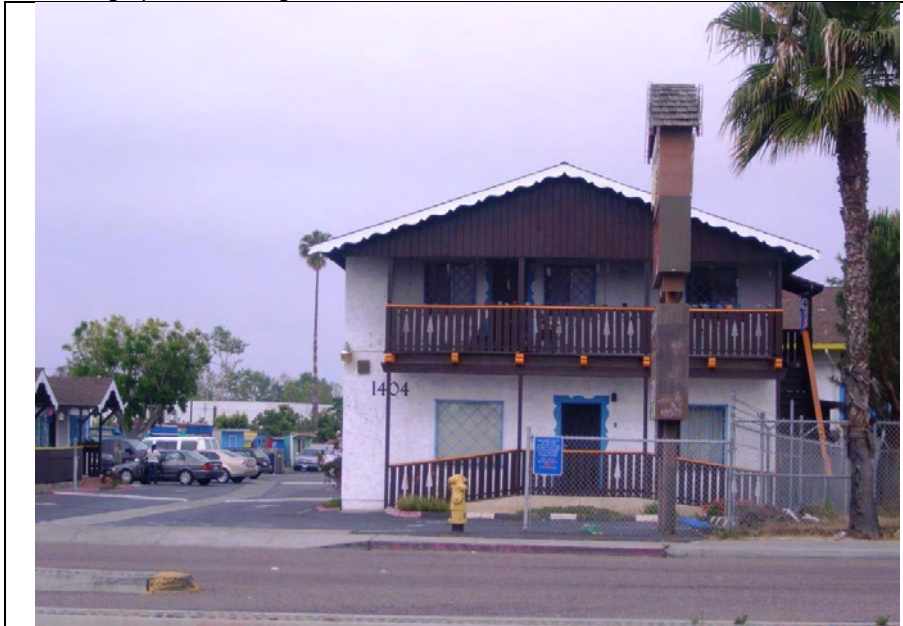
View looking west at the motel.

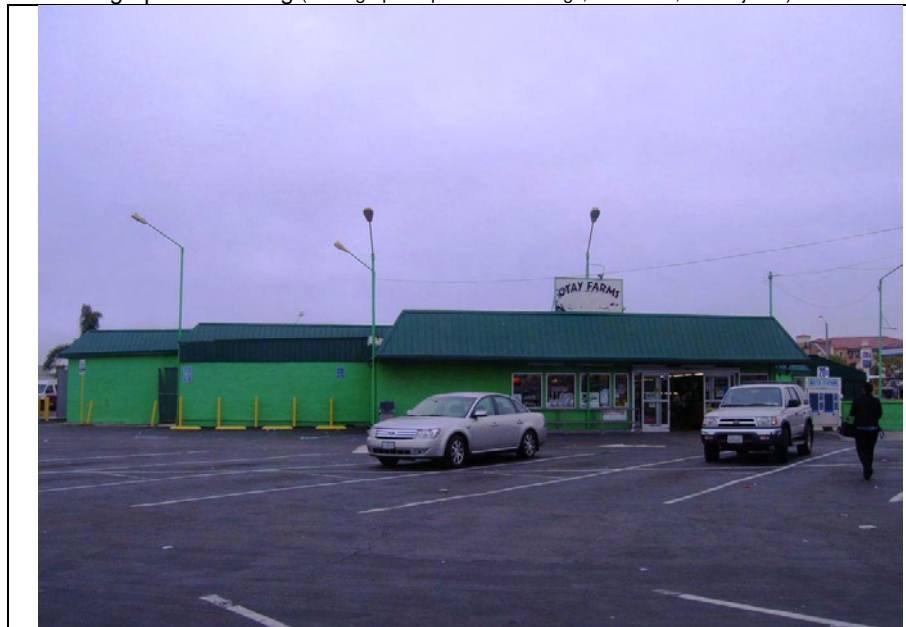
View looking north at the property.

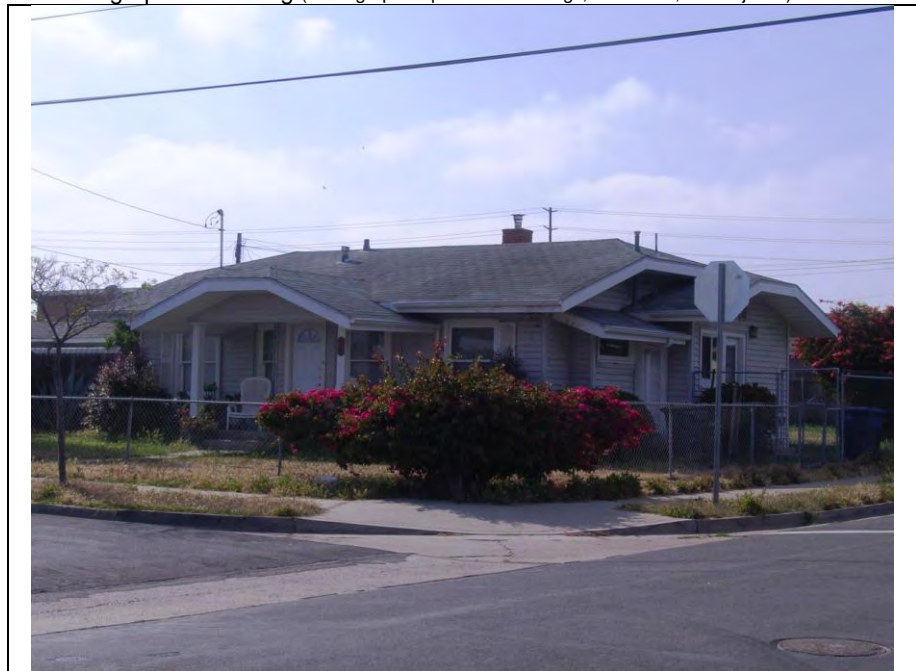
View looking southeast at the building.

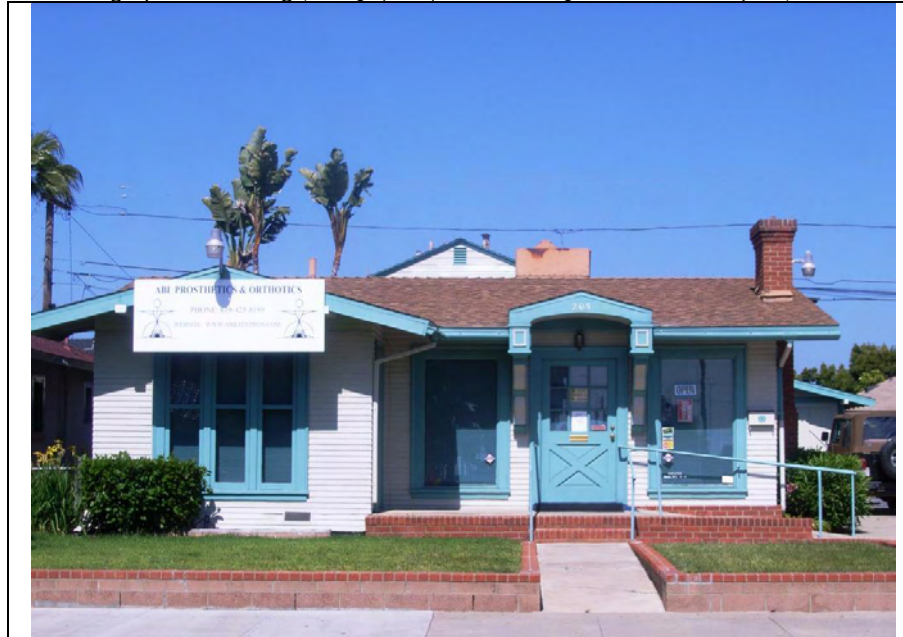
View looking east at the building.

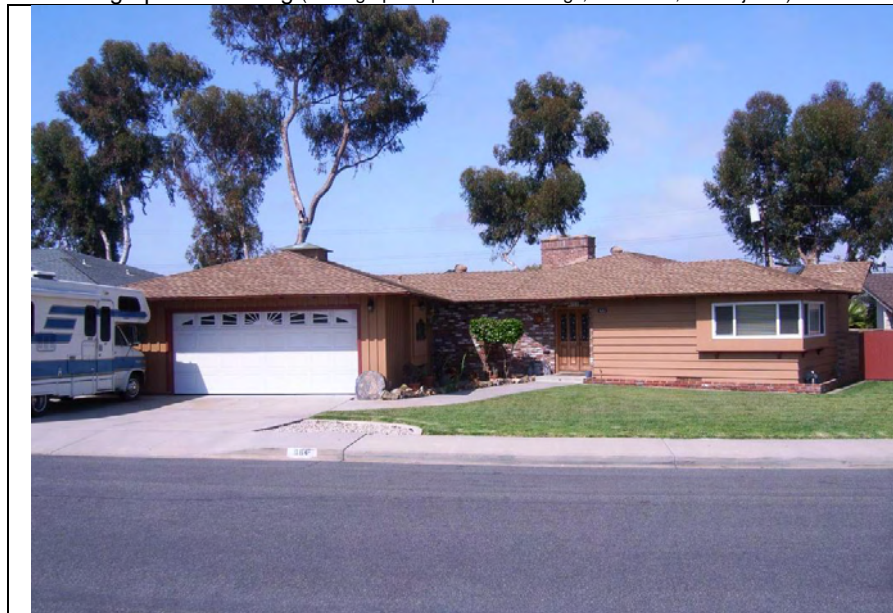
View looking west at the building.

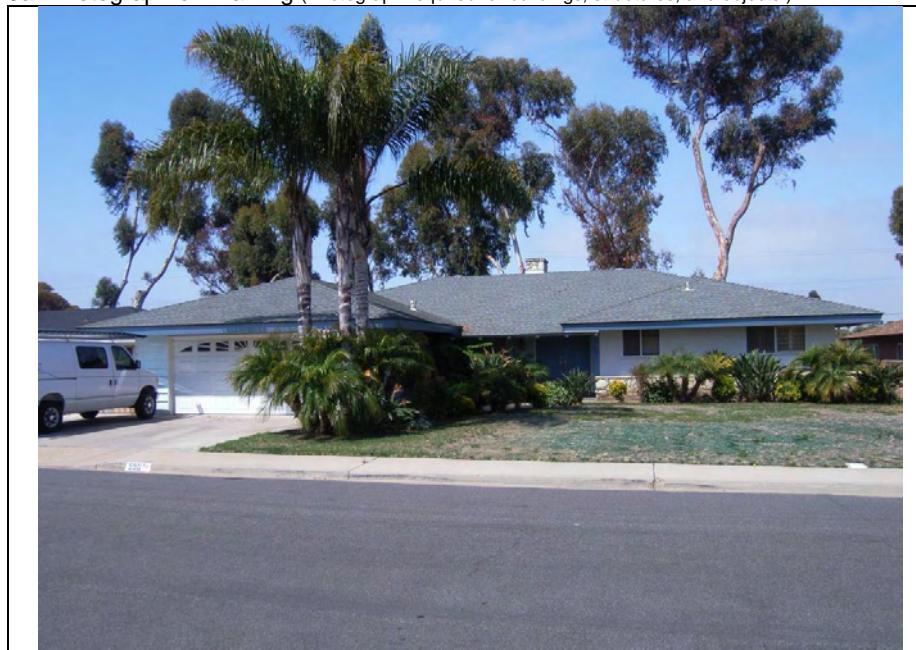
View looking west at the building.

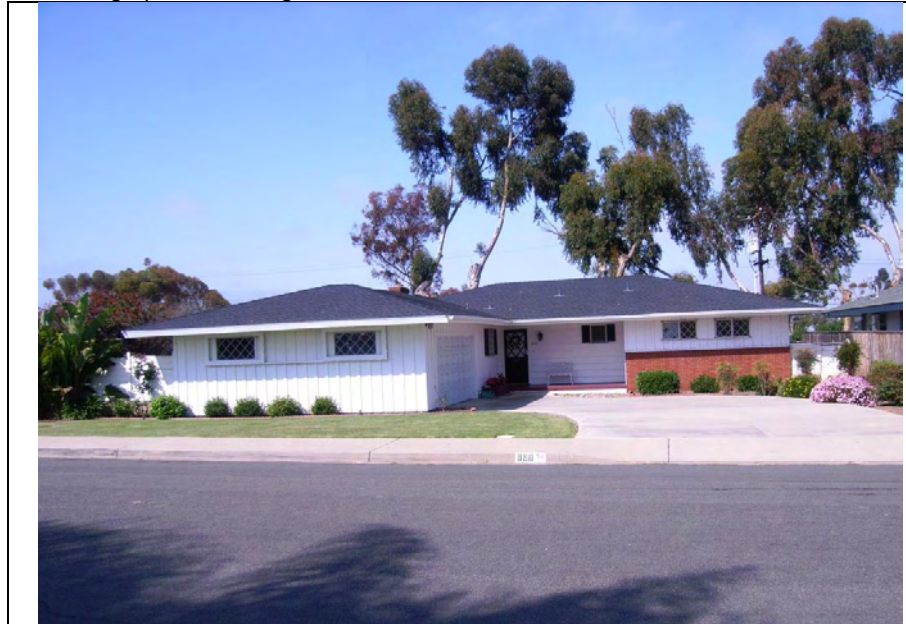
View looking west at the building.

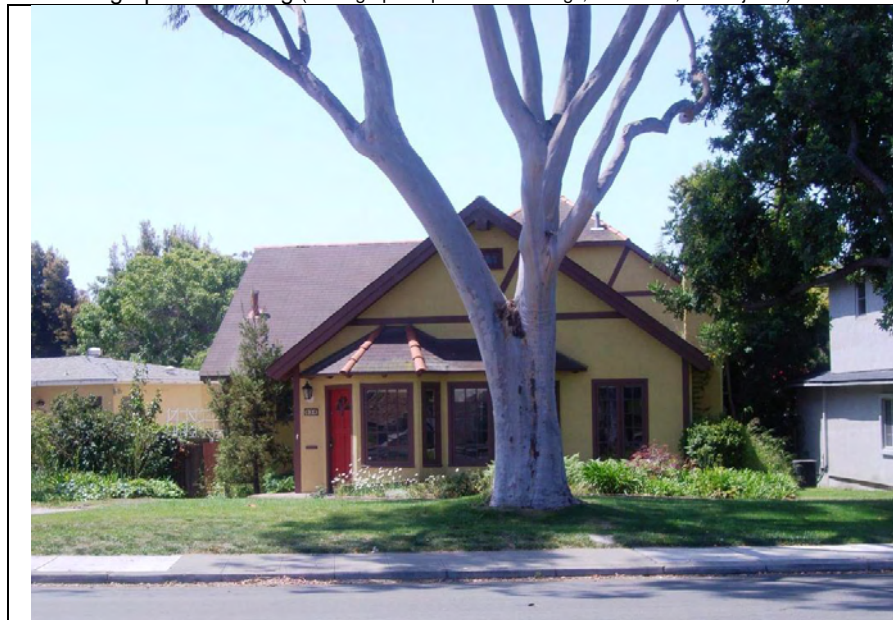
View looking south at the building.
